# New Hampshire Volunteer Lake Assessment Program

## 2003 Interim Report for Harvey Lake Northwood

NHDES  
Water Division  
Watershed Management Bureau  
29 Hazen Drive  
Concord, NH 03301

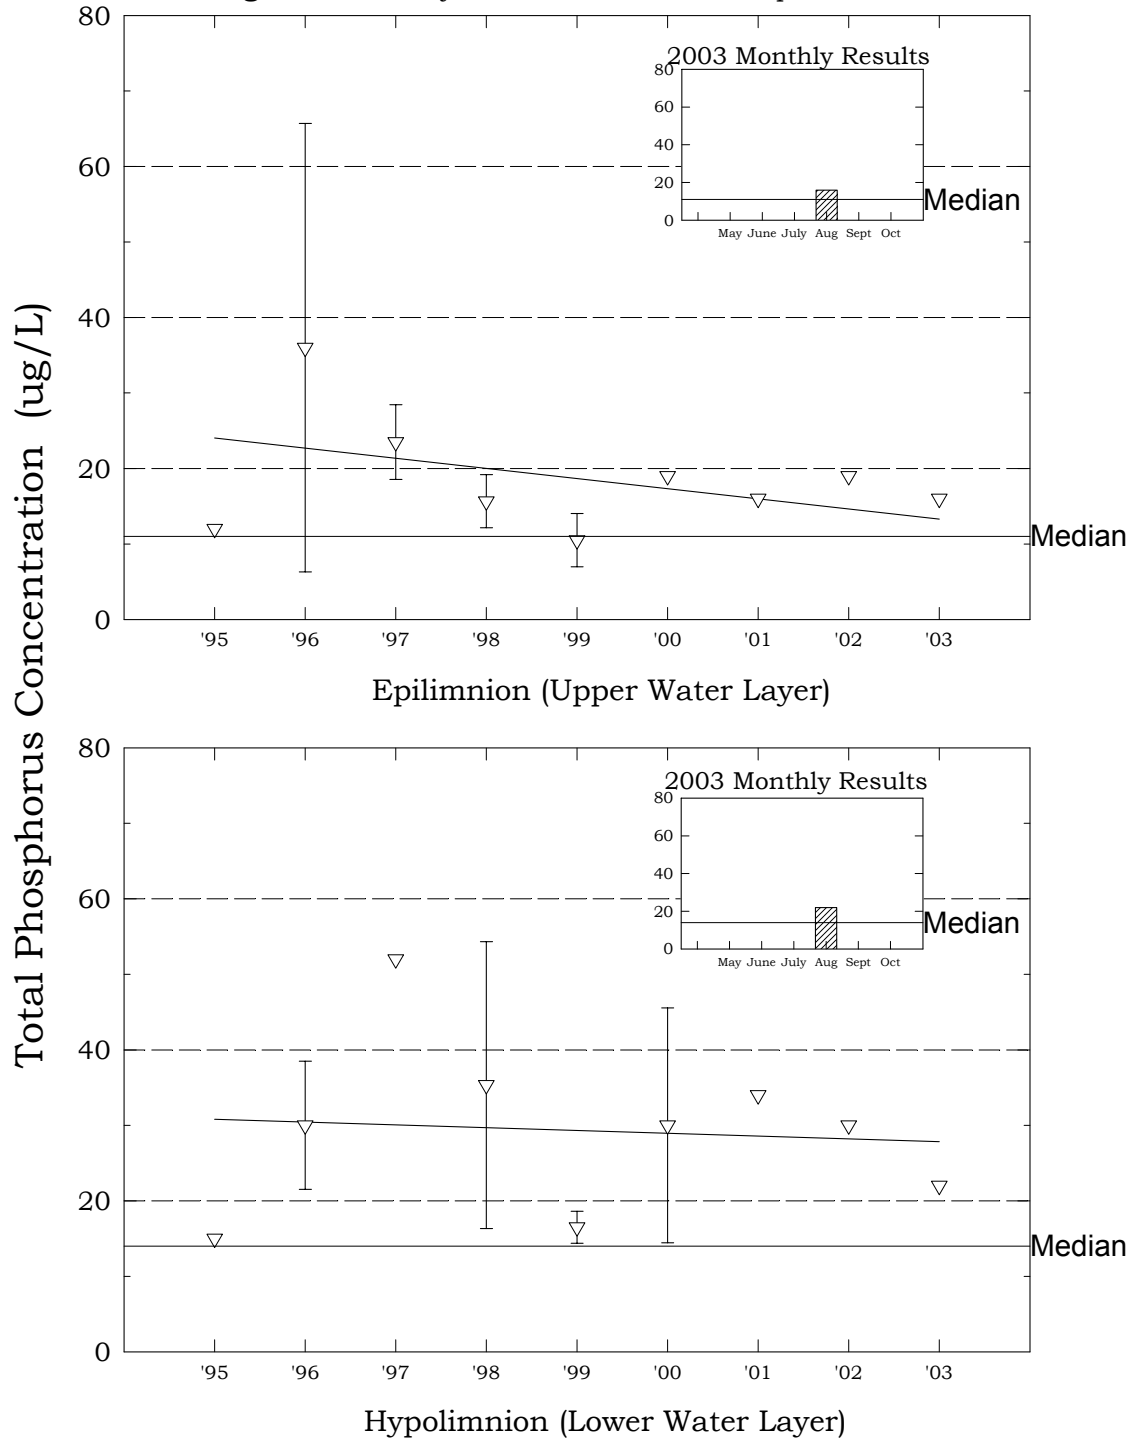
**Figure 3.** Monthly and Historical Total Phosphorus Data.

- **Figure 3 and Table 8:** The graphs in Figure 3 (Appendix A) show the amounts of phosphorus in the epilimnion (the upper layer) and the hypolimnion (the lower layer); the inset graphs show current year data. Table 8 (Appendix B) lists the annual maximum, minimum, and median concentration for each deep spot layer and each tributary since the lake/pond has joined the program.

The current year data for the epilimnion (the top inset graph) and the hypolimnion (the bottom inset graph) show that the phosphorus concentration in August was ***slightly greater than*** the state median.

Overall, visual inspection of the historical data trend line for the epilimnion and the hypolimnion show a ***variable*** phosphorus trend, which means that the concentration has ***fluctuated, but has not continually increased or decreased***, since monitoring began.

One of the most important approaches to reducing phosphorus loading to a waterbody is to continually educate watershed residents about its sources and how excessive amounts can adversely impact the ecology and value of lakes and ponds. Phosphorus sources within a lake or pond's watershed typically include septic systems, animal waste, lawn fertilizer, road and construction erosion, and natural wetlands.
